MOVE Type D & DL Keyset Retrofit Implementation Plan

Network Support Group Splinter

JSC

10/19/11

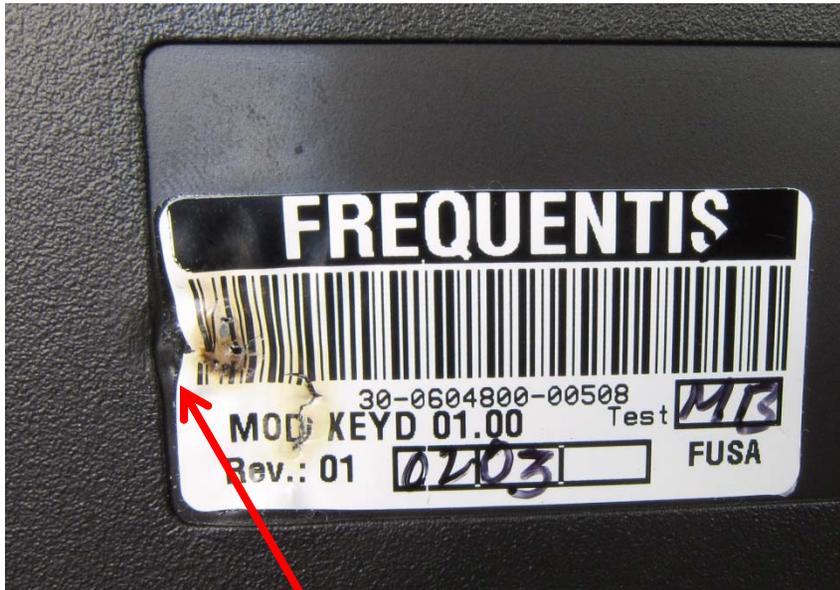
Burn mark on back of Keyset

Pictures of JSC Failed Keyset after 20 hours of arcing

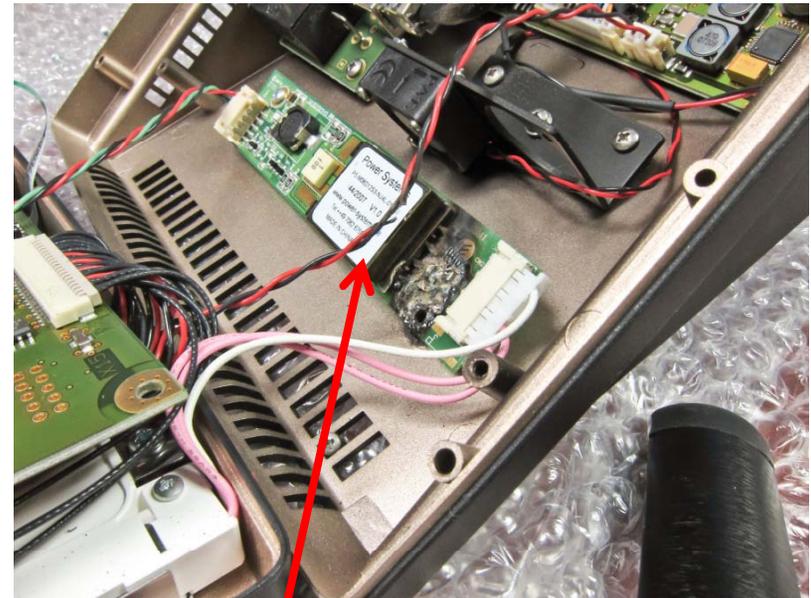
Power Inverter Board

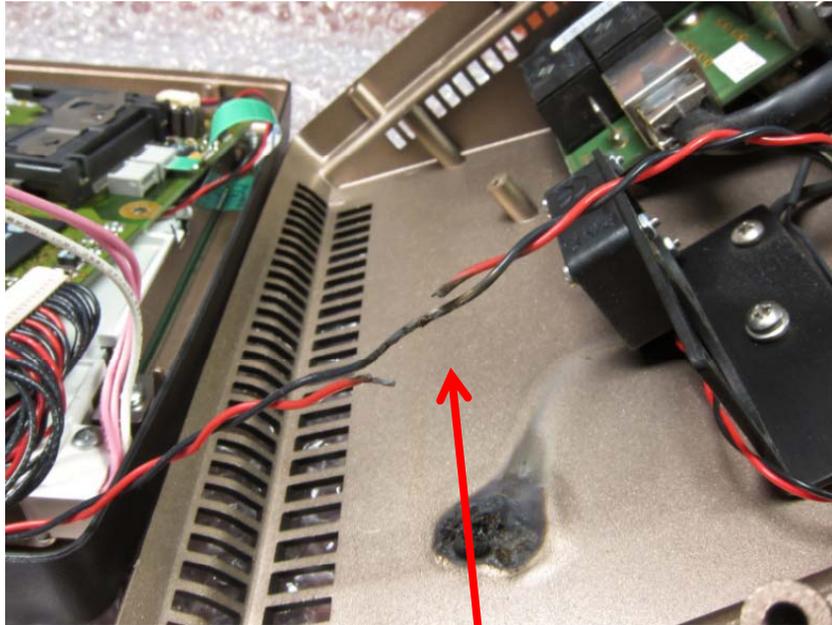
Speaker wire consumed by arcing

Pictures of JSC Failed Keyset after 20 hours of arcing

- Reroute the speaker wire away from the high voltage side of the power inverter board and ensure it has an insulation $\geq 1,200$ v rated dielectric material.
 - Replace the metal screw/washer nearest the inverter output pin with a fire retardant rated plastic screw/washer
 - Coat the entire power Inverter Board High Voltage section with an insulating conformal coating compound. This will prevent material (dust, dirt, etc.) from shorting. The areas to be covered are the transformer high voltage output pins, associated circuit tracks, associated capacitors, and the connector pins for the high voltage cable.
 - Fuse the power Inverter board input. This will ensure that even if the arcing were ever to reoccur, the inverter board will not be allowed to continue to arc because the fuse would blow.

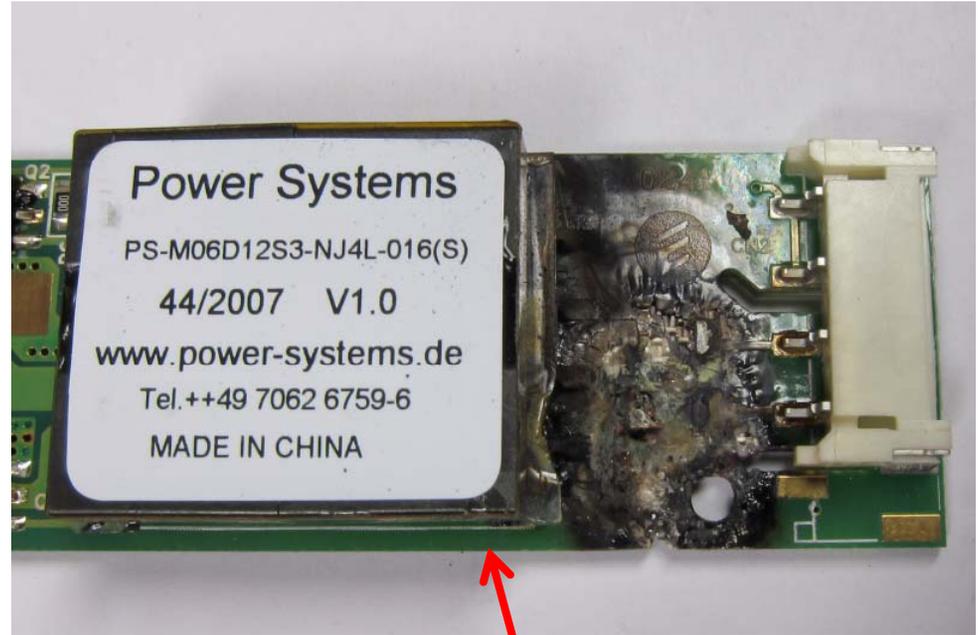
Power Inverter Board, High Voltage side

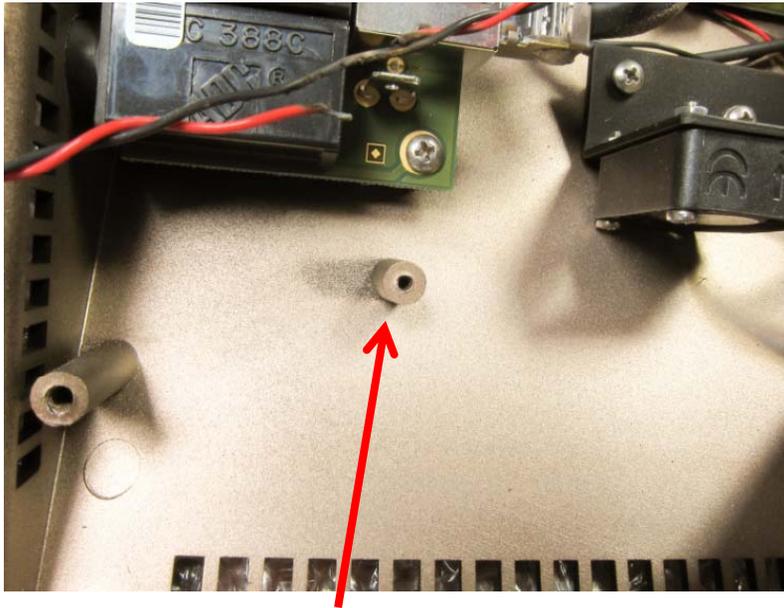
Keyset housing power Inverter Board mounting standoff (Low Voltage side)

Pictures of JSC Failed Keyset after 20 hours of arcing

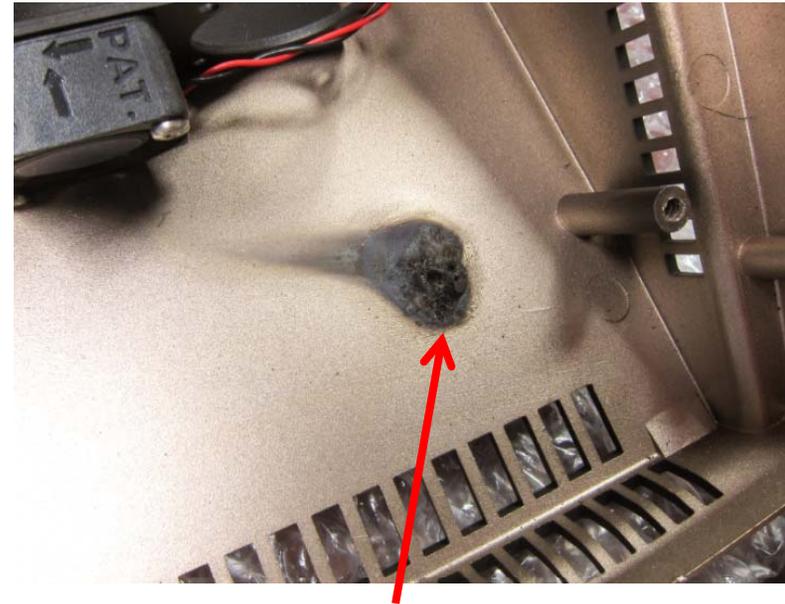
Keyset housing power Inverter Board mounting standoff (High Voltage side) consumed by arcing

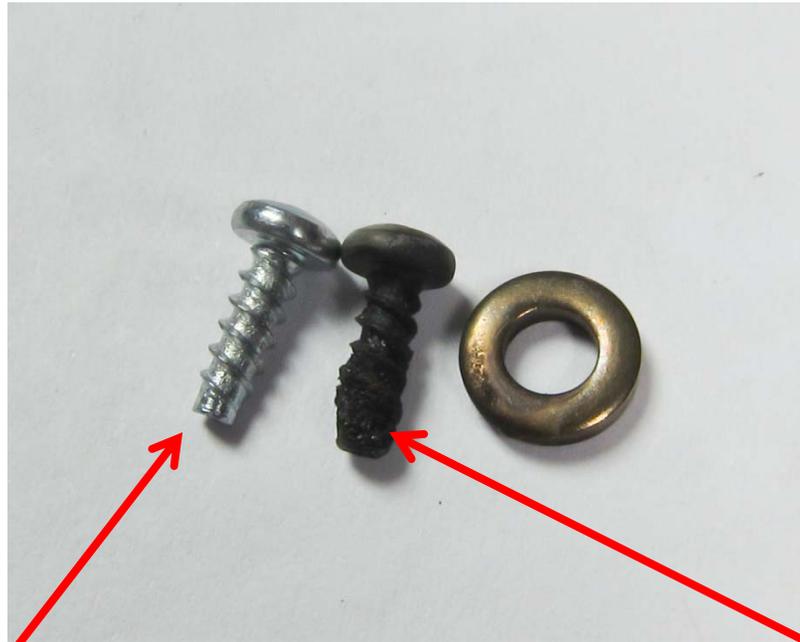
Power Inverter Board mounting screw
Low voltage side

Power Inverter Board mounting hardware
High voltage side

Pictures of JSC Failed Keyset after 20 hours of arcing
