MILA Critical Path Audit

Cheryl Dry

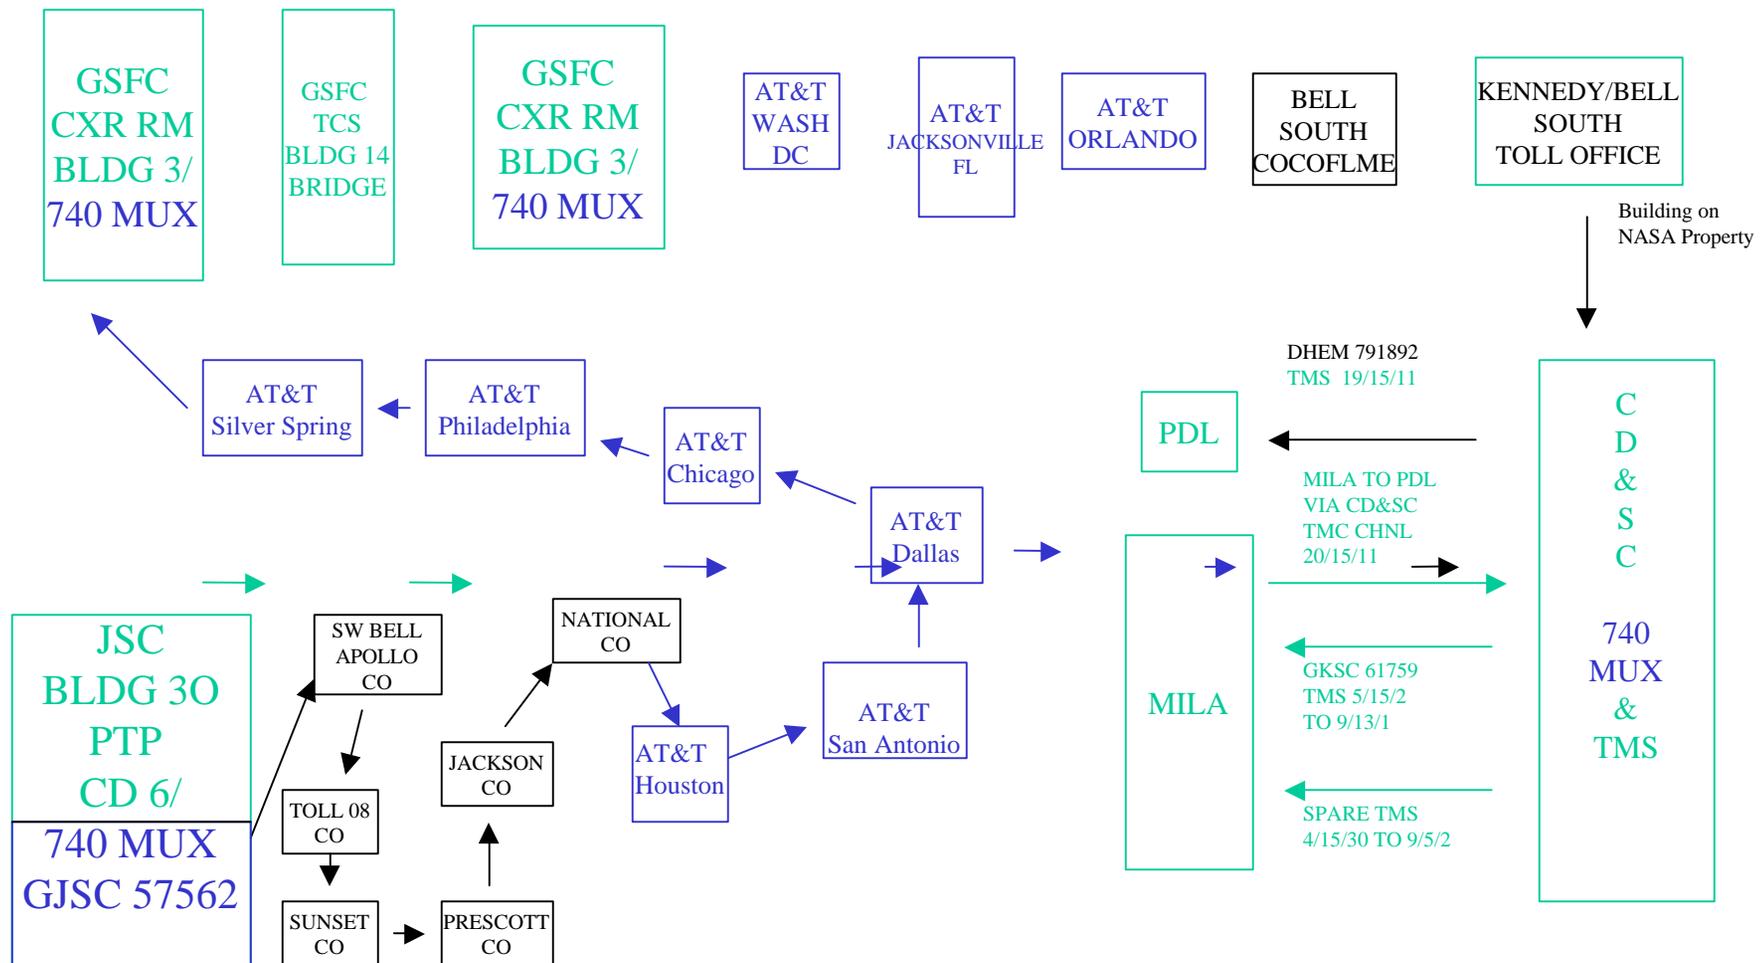
72kb PRIME STS CMD Prime Path

- » **Issue** - During the STS-101 TCDT problems were experienced on the Prime and Back up CMD interfaces. The Prime T-1 was affected by circuit outages in the JSC area. JSC went to the Back up CMD interface and experienced errors there too. The problem on the Back up was found to be with the card in the TMS, it was not strapped correctly. The card options were changed on the Back up, this restored that interface. Problems resolved on Prime when circuits were restored.

- » **Recommended Resolution:** A spare interface between CD&SC and MILA was identified.
